# Manhole Inspection Summary

Manhole # S11O\_\_018MH

**Location** Address: **3208 Frederick**

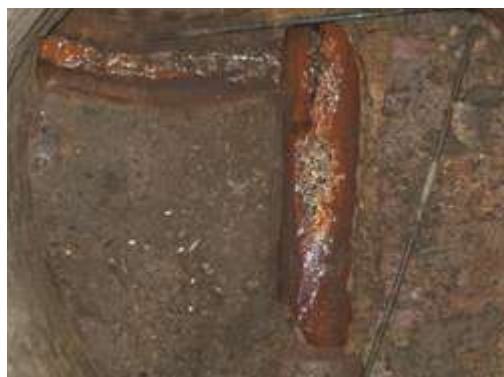
Defect 3

Condition: ☐ Sound ☐ Cracked ☐ Root Intrusion ☐ Deteriorated ☐ Leaks ☒ **Debris**

bench debris

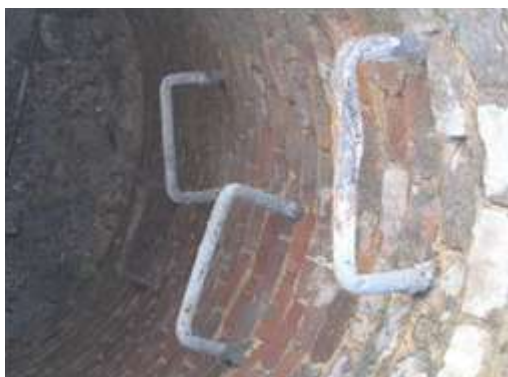
Defect 1

Infiltration: ☐ None ☐ Joint ☐ Cracks ☐ Mortar ☐ Roots ☒ **Wall**

Count: **4** Missing: **0** ☒ **Corroded**

corroded steps, chimney and corbel infiltration

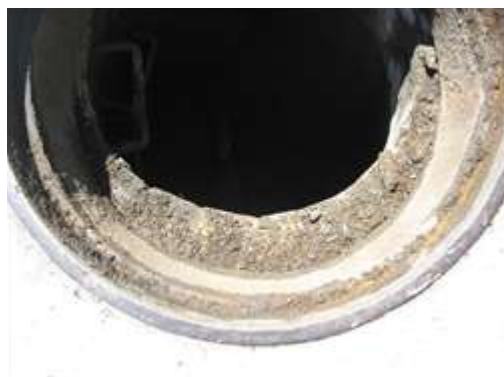
Defect 4

Offset: **4** (in.)

frame offset 4"

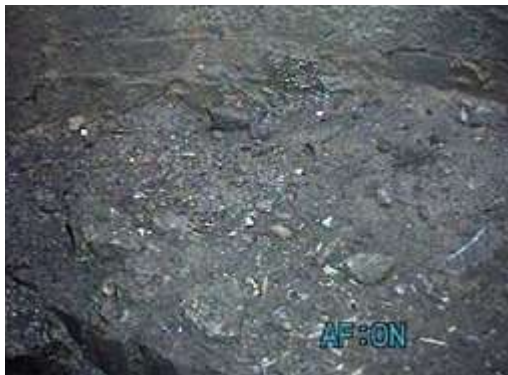
### Defect 2

Infiltration: ☐ None ☐ Joint ☐ Cracks ☐ Mortar ☐ Roots ☒ **Wall**

Sediment deposits on bench, evidence of barrel infiltration

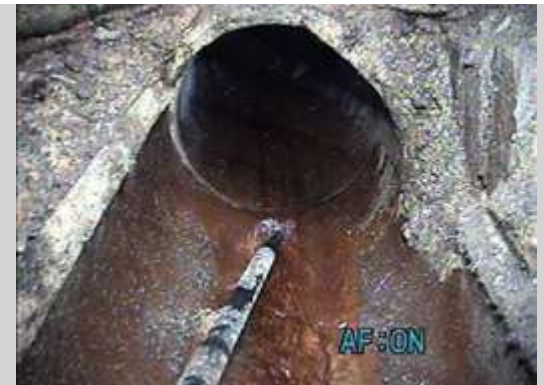
6 O'Clock Inflow

Pipe Height: **7.2** (in.) Rod and Bar (Angled)  
Pipe Material: **Clay** ☐ Pipe Lined  
Invert Depth: **8.12** (ft.) Flow Characteristics: **Fast**  
Deposits: ☒ None ☐ Mud ☐ Sludge ☐ Debris ☐ Grease  
Silt Depth: **0** (in.) Deposits Extent:  
Infiltration: **Evidence** Pipe Seal Cond: **Unknown**

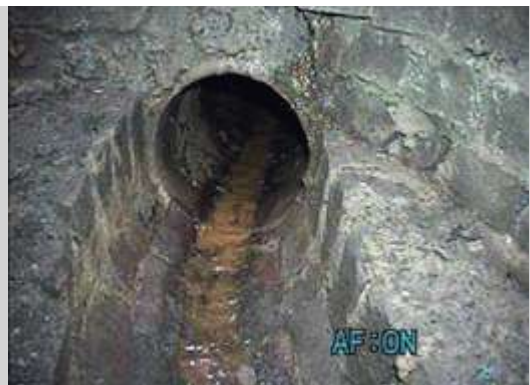
10 O'Clock Inflow

Infiltration: **Evidence** Pipe Seal Cond: **Unknown**
